Design Guidelines For The
Historic Districts
of the
City of San Marcos, Texas

Commercial Guidelines

Design Guidelines for Commercial Buildings in the
Historic Districts of San Marcos

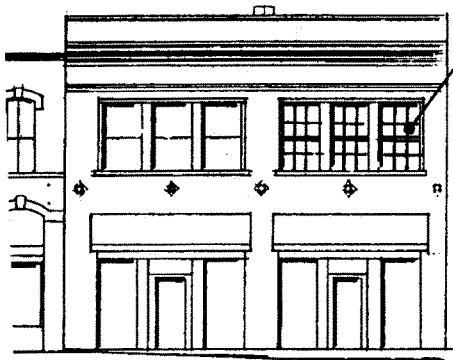
AVOID INSTALLING
WINDOWS THAT DO NOT
FIT THE STYLE AND PERIOD

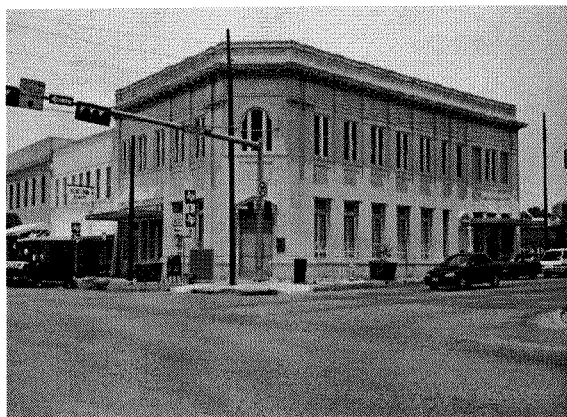
CORNER BUILDING WITH TWO "FRONT" FACADES

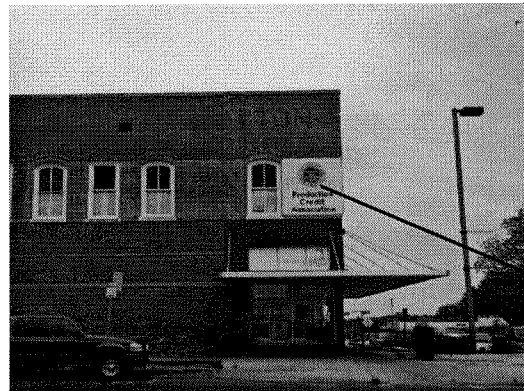
SIDE ELEVATION OF DIFFERENT MATERIAL

SIGNAGE PAINTED ON SIDE WALL

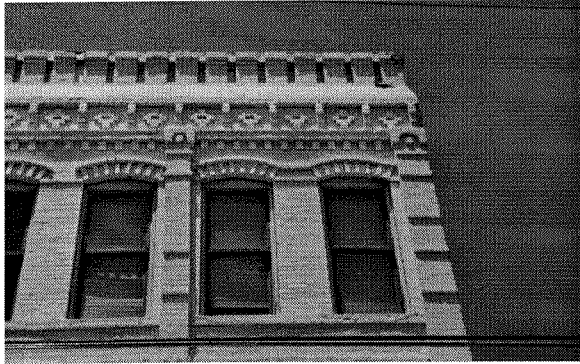
BRICK DETAILS IN ARCHES
AND CORNICE

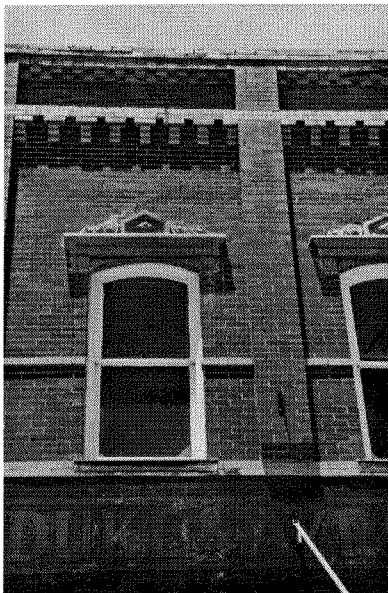
BRICK
CORNICE

BRICK
BANDING

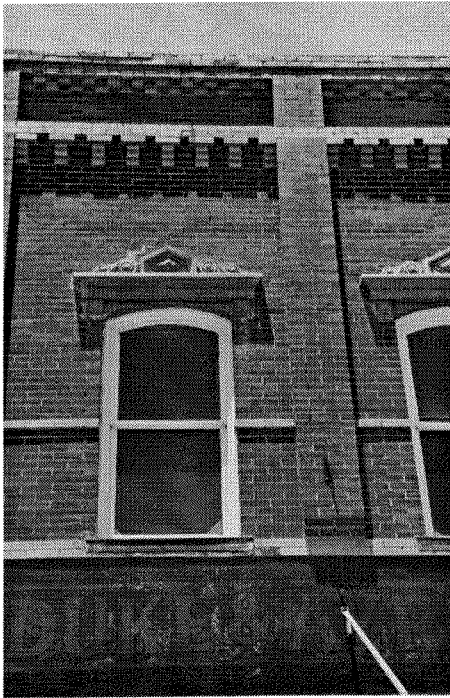
PRESSED
METAL
WINDOW
HOODS

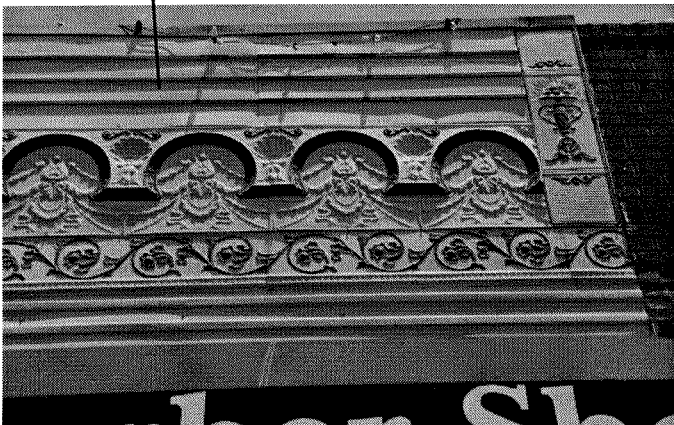
METAL CORNICE

CAST IRON -
WINDOW HOODS
ARE UNIQUE
DETAIL

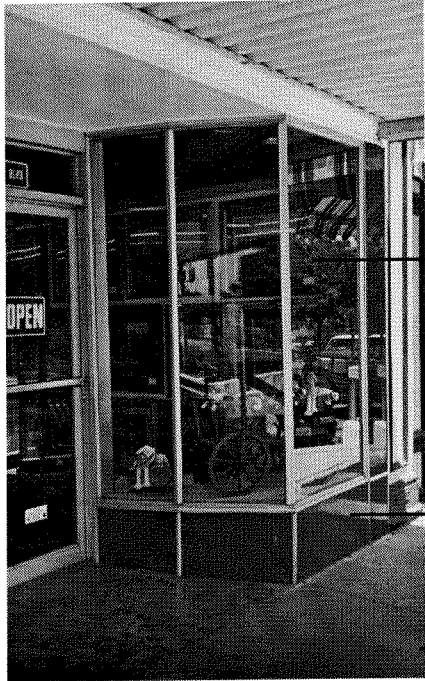
RETAIN
CLEAR GLASS
DISPLAY
WINDOW

GLASS AT
BASE/KKK
PLATE

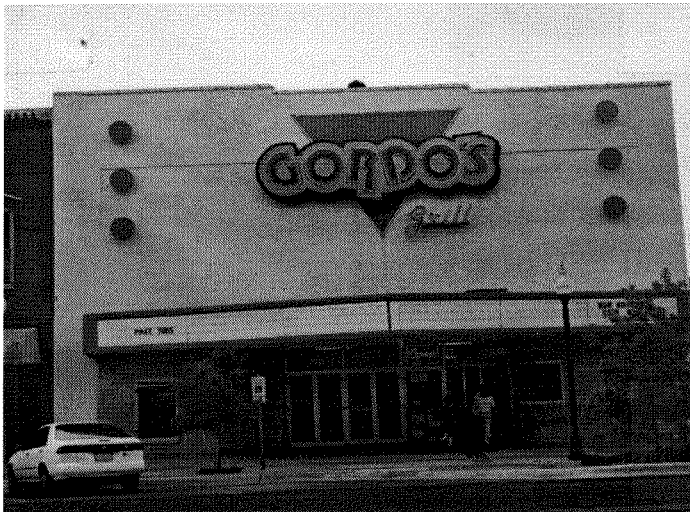
APPROPRIATE APPLICATION OF STUCCO
